**DEPARTMENT OF TRANSPORTATION**

Quality Assurance and Source Inspection

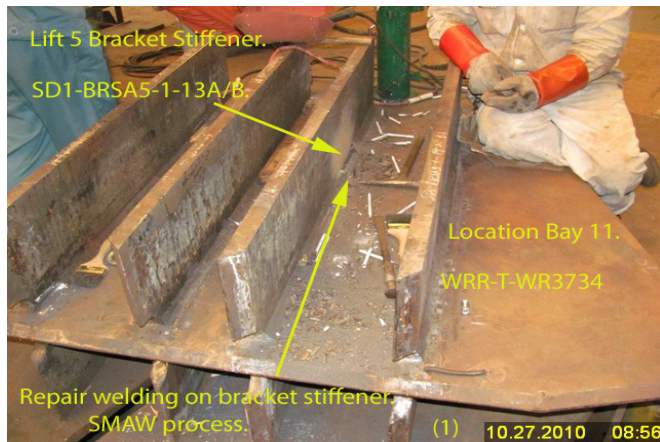
This QA Inspector observed ZPMC qualified welding personnel identified as 202100 Perform Shielded Metal Arc Welding (SMAW) on Lift 5 Bracket stiffener. Joint identified as SD1-BRSA5-1-13A/B. ZPMC QC Identified as Shao Hai Lang with Temporary welding repair report WRR-T-WR3734. The welding parameters as measured using QC's calibrated instrument appeared to be in general compliance with WPS-485-SMAW-2G (2F) –Repair 1. For more information see below attached picture number 1.

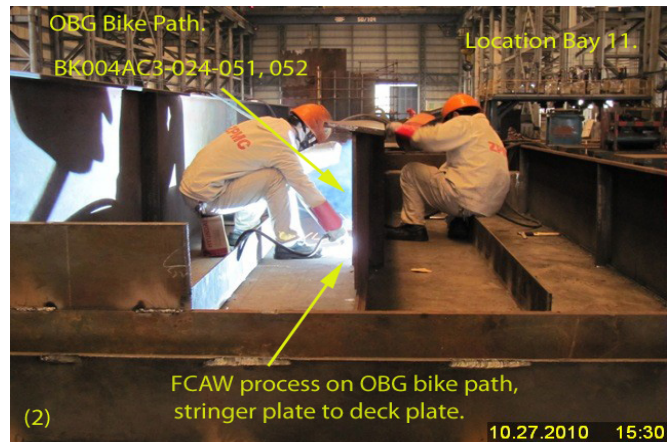
This QA Inspector observed ZPMC qualified welding personnel identified as 042218, 049220, Perform Flux Core Arc Welding (FCAW) on OBG bike path plate. Joint identified as BK004C3-024-051, 052. ZPMC QC Identified as Xu Jie. The welding parameters as measured using QC's calibrated instrument appeared to be in general compliance with WPS-B-T-2132. For more information see below attached picture number 2.
